**NASA TM X-73988**

**EFFECT OF LOW VELOCITY IMPACT DAMAGE ON THE COMPRESSIVE STRENGTH  
OF GRAPHITE/EPOXY HAT-STIFFENED PANELS**

**Marvin D. Rhodes, Jerry G. Williams, and James H. Starnes, Jr.**

**December 10, 1976**

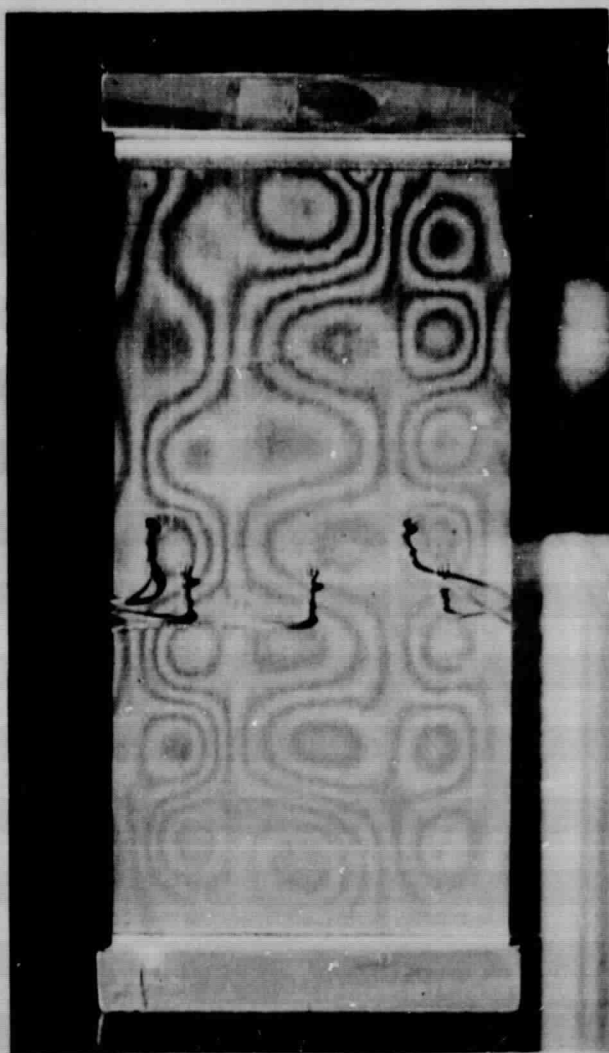
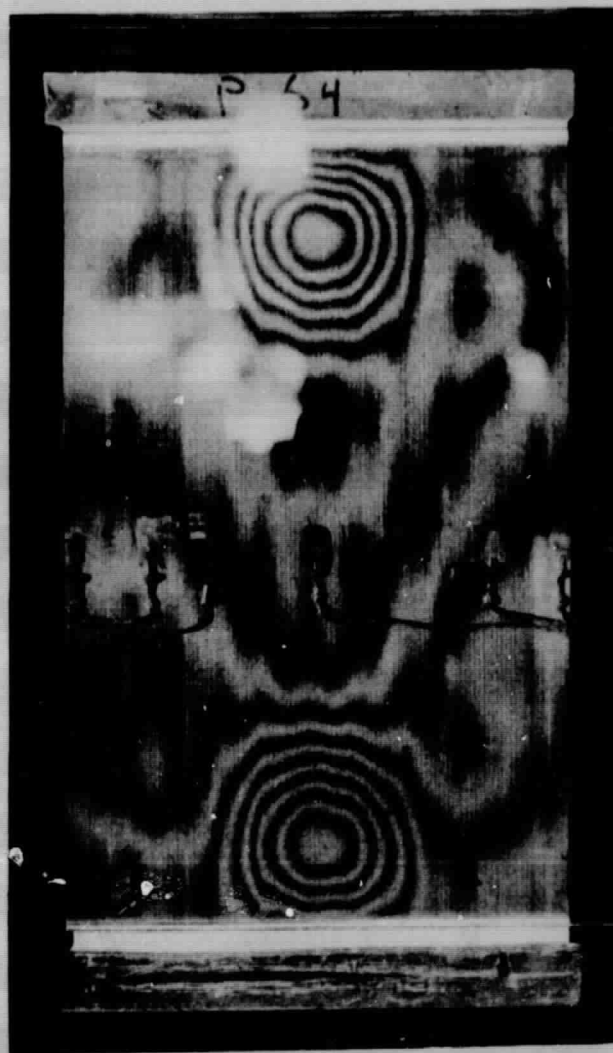
Three panels of design A and four of design B were tested in the undamaged condition to evaluate panel behavior due to applied axial compressive load. The behavior of each panel for the indicated load and strain is presented in table II. The type A panels buckled near the design strain of 0.0034 and exhibited postbuckling behavior. The type B panels exhibited strength failure near the design strain of 0.0080 prior to buckling. A photograph of a typical normal displacement field as indicated by the moiré fringe pattern for each design configuration is shown in figure 3. Test panel A1 (figure 3a) has a fully developed buckle pattern at an imposed strain of 0.0036. Test panel B2 (figure 3b) is shown at an imposed axial strain of 0.0079 which is near the strain at which the panel exhibited failure. The pattern seen at the ends of the panel is the result of inplane restraints imposed by the flat-end test condition (ref. 2).

a) Panel A1 designed for strain of 0.0034 loaded to an applied axial strain of 0.0036.

b) Panel B2 designed for strain of 0.0080 loaded to an applied axial strain of 0.0079.

Figure 3.- Photographs of the moiré fringe patterns for typical undamaged panels during compression tests.

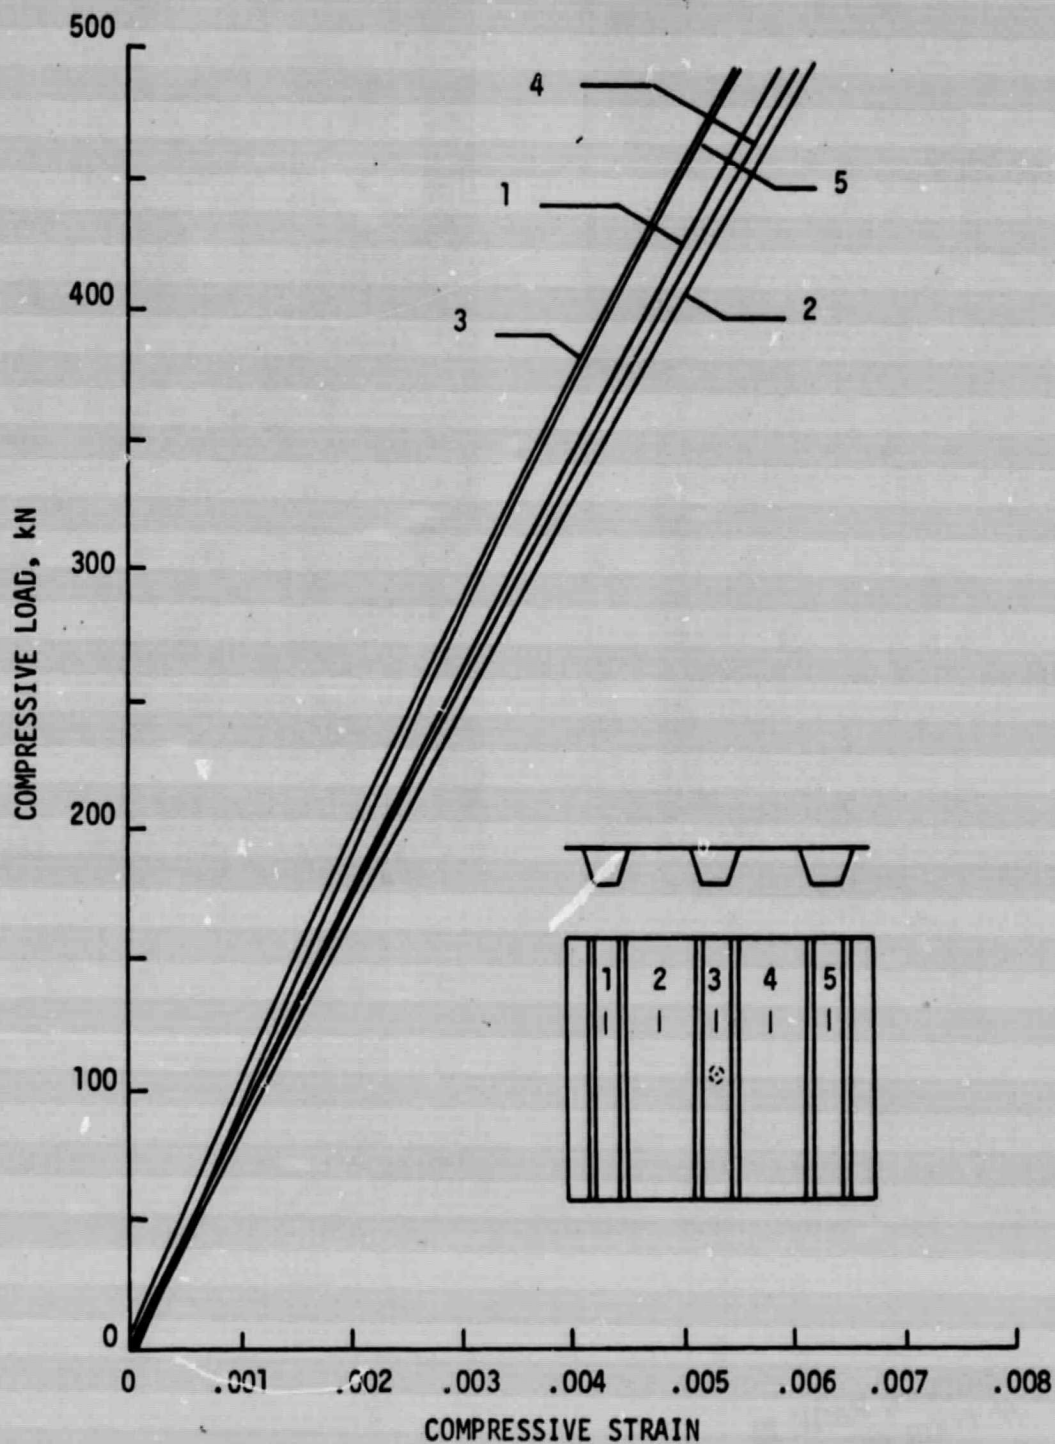
The panel (B5) with the 1.27 cm diameter cutout was loaded to failure in axial compression. Far-field axial strains were measured during the test by five strain gages located on a line across the panel, 6.35 cm from the cutout center. The location of those gages and the measured strains as a function of applied load are shown in figure 4. These data indicate a nearly uniform far-field axial strain distribution across the panel and a linear load-strain relationship to failure. The average of these gages is subsequently referred to as the applied strain. Panel failure occurred at an applied strain of 0.0058 (applied load of 496 kN) which is 73 percent of the 0.0080 design strain.

Figure 4.- Compression load-strain curves at 5 locations across Panel B5 which has a 1.27 cm diameter cutout in the high axial stiffness region of the center stiffener.

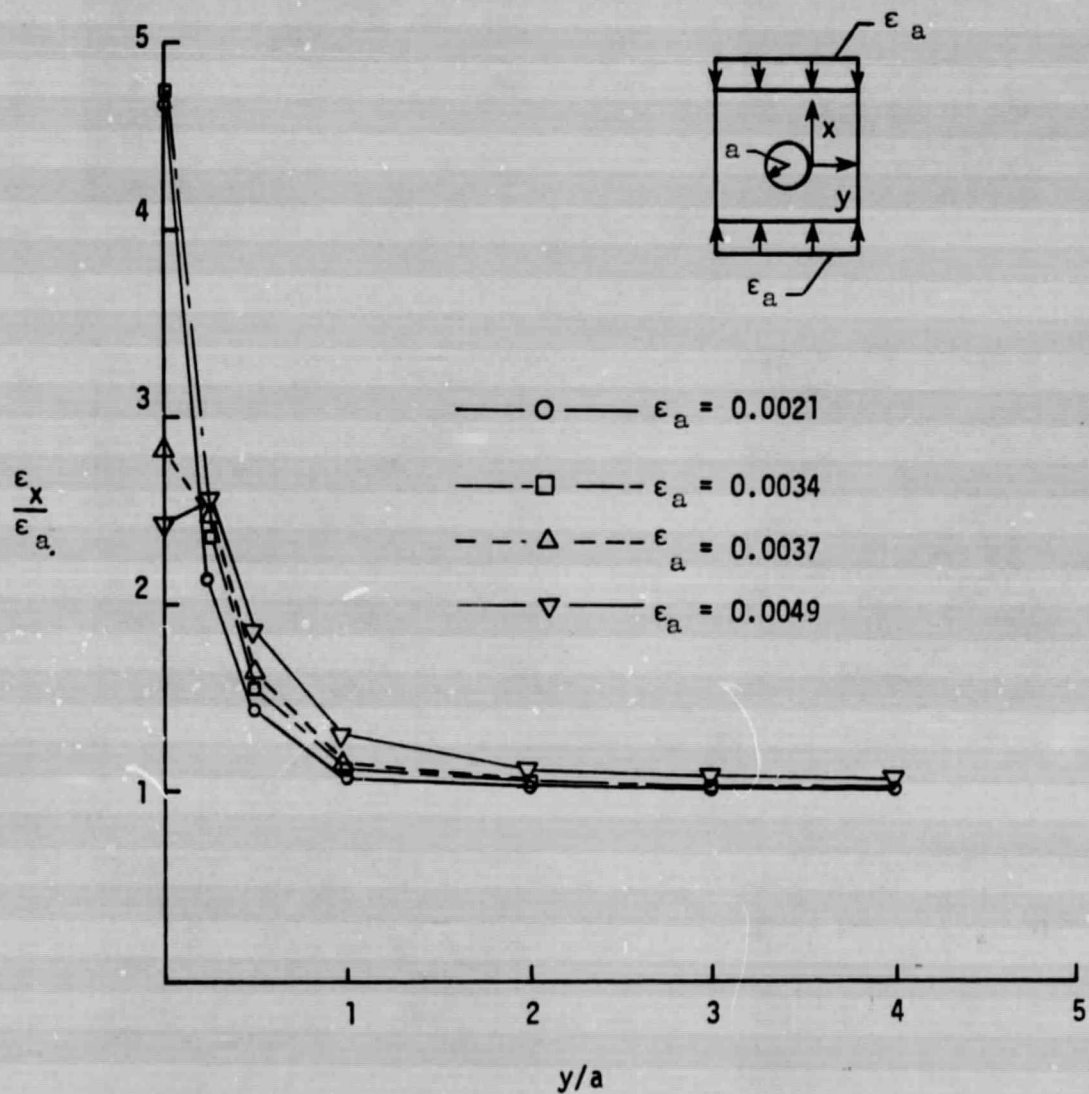
Several strain gages were located at points along a line across the panel passing through the cutout center to determine the variation in axial strain in the neighborhood of the cutout. These gages were closely spaced near the cutout and one gage was located on the cutout free-edge surface. The distribution of strain as determined by these gages across the right side of the panel is shown normalized by the applied strain in figure 5 for several

values of applied strain. The origin of all curves on figure 5 is indicated in the sketch on the figure and the distance  $y$  from the cutout edge has been normalized by the cutout radius. The strains are several times greater near the cutout edge than those three cutout radii away and there are steep strain-gradients near the cutout edge. Up to an applied strain of about 0.0034 the strain at the cutout edge is approximately 4.6 times greater than the far-field strain. At an applied strain of 0.0034 the strain at the cutout edge was 0.016 and then dropped suddenly to 0.012. It is suspected that a local material failure occurred in the zero degree laminae at this very high strain level. At applied strains between 0.0034 and 0.0049 the strains at the cutout edge were only 2.4 to 2.8 times as great as the far-field strains as indicated by the results shown on figure 5.

Figure 5.- Strain measured in the vicinity of the 1.27 cm diameter cutout on Panel B5.  $\epsilon_x$  denotes measured strain at indicated location at an applied axial panel strain of  $\epsilon_a$ .

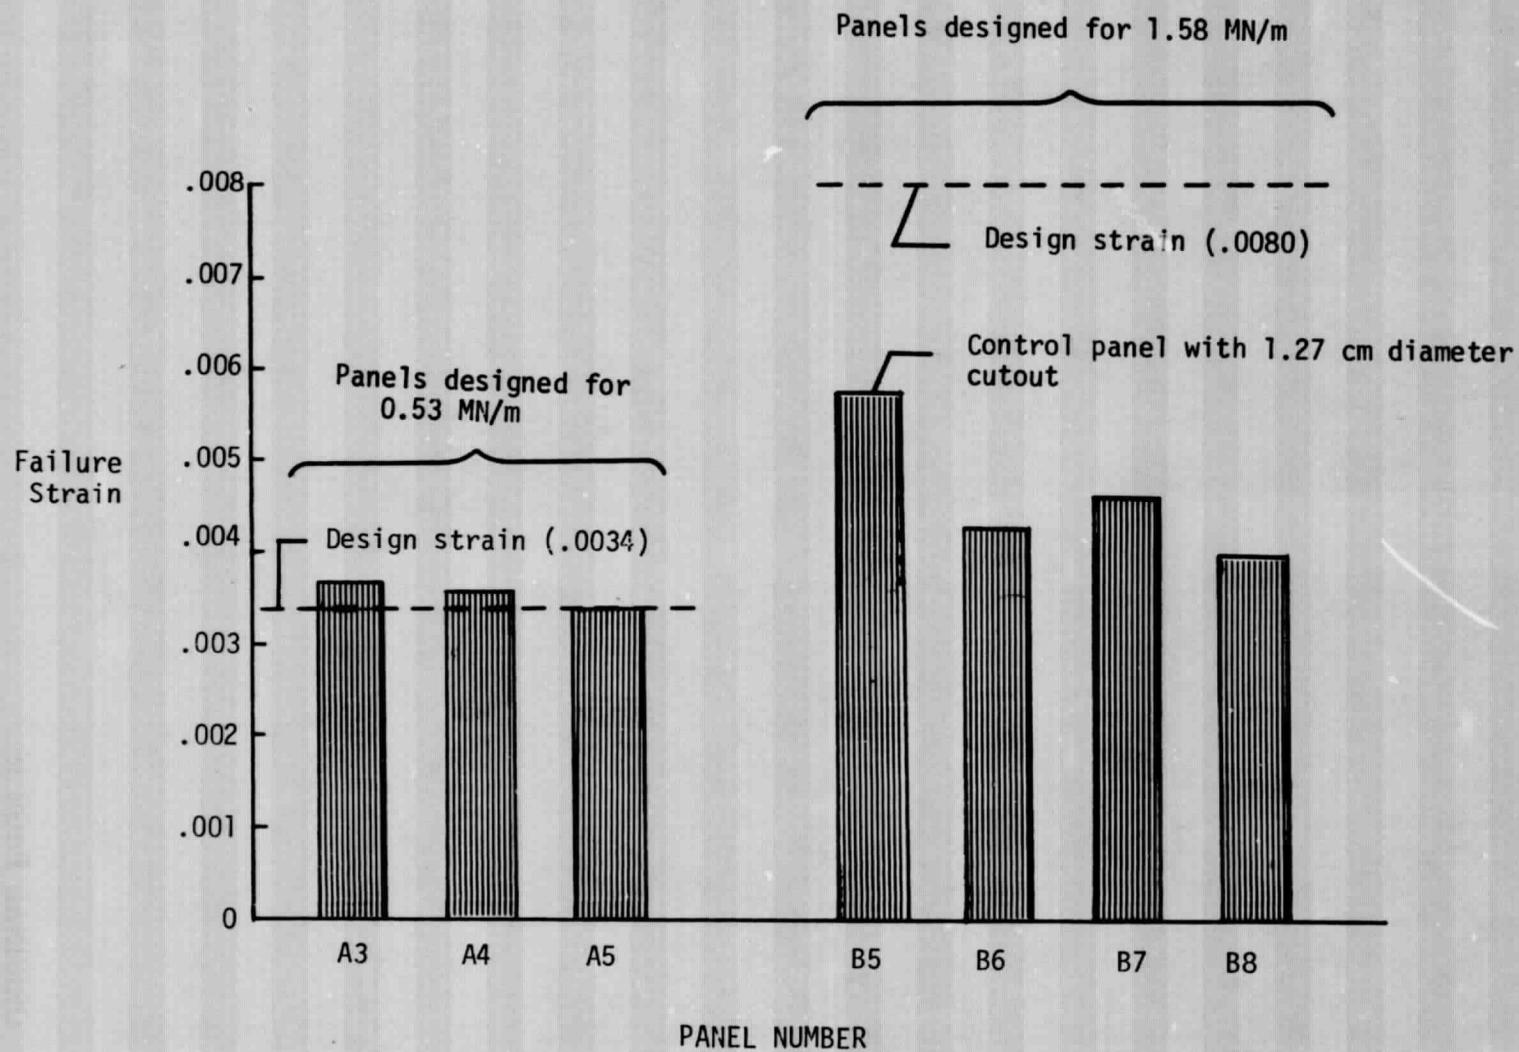
Impact damage characterization.- A comparison of test results for impact in the high axial stiffness region indicates both similarities and differences in the results for panels of design A and design B. The extent of local damage induced by impact increased with the magnitude of applied axial-compressive strain for both designs. The design A panels satisfied the design-strain requirements with impact damage and also exhibited post buckling behavior. The design B panels, however, failed due to impact damage at applied axial strains between 50 and 58 percent of the design strain level. The impact test results for both designs are summarized in figure 12 along with the cutout test data for comparison. Limited local impact damage that was not noticeable by visual inspection (Panel B6) reduced the ultimate strength of the design B panels as much as extensive visible localized damage (Panel B7). All three of the design B panels damaged by impact failed at lower applied strain levels than the control test panels with the 1.27 cm diameter cutout. The damaged region caused by impact, however, was larger than the controlled cutout. In all cases, the damage in the high axial stiffness region precipitated failure at an applied strain well below the design strain level.

Figure 12.- Comparison of failure strains for panels damaged in high axial stiffness region.
